DEPARTMENT OF TRANSPORTATION

Quality Assurance and Source Inspection

Contract #: 04-0120F4Cty: SF/ALA Rte: 80 PM: 13.2/13.9File #: 69.28**WELDING INSPECTION REPORT****Resident Engineer:**Pursell, Gary**Address:** 333 Burma Road**City:** Oakland, CA 94607**Report No:** WIR-006622**Date Inspected:** 03-May-2009**Project Name:** SAS Superstructure**OSM Arrival Time:** 1845**Prime Contractor:** American Bridge/Fluor Enterprises, a JV**OSM Departure Time:** 645**Contractor:** Zhenhua Port Machinery Company, Ltd (ZPMC), Changxing Island **Location:** Shanghai, China**CWI Name:** Liu Liang**CWI Present:** Yes No**Inspected CWI report:** Yes No N/A**Rod Oven in Use:** Yes No N/A**Electrode to specification:** Yes No N/A**Weld Procedures Followed:** Yes No N/A**Qualified Welders:** Yes No N/A**Verified Joint Fit-up:** Yes No N/A**Approved Drawings:** Yes No N/A**Approved WPS:** Yes No N/A**Delayed / Cancelled:** Yes No N/A**Bridge No:** 34-0006**Component:** OBG**Summary of Items Observed:**

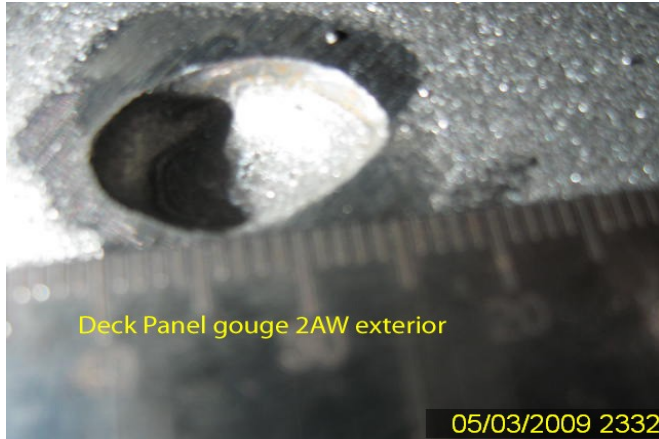
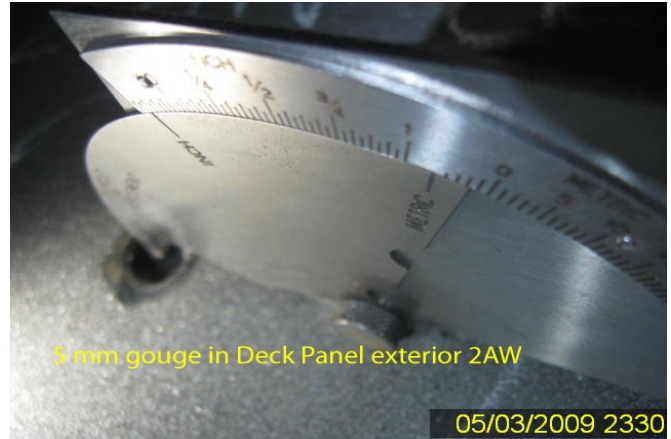
This QA Inspector performed a preliminary random visual inspection after the grit blast of the exterior components of assemblies of segment 2AW. Numerous Gouges in the Base metal where temporary welds were removed by ZPMC were found in various locations on exterior Deck Panel components. Gouges up to 5 mm in depth were found. Numerous arc strike areas were found during inspection and were marked for grinding. ZPMC personnel did not perform Magnetic Particle Inspection after grinding of these areas prior to grit blasting. ZPMC QC personnel were made aware of these locations. Below are photos of one of the gouge areas that were observed during this inspection. An incident report was issued for the above mentioned items of non conformance.

This QA Inspector observed the following work in progress: SAW welding of weld joint 146 and 147 located on

Tower component NSD1-TL8E-L. ZPMC welder was identified as Jia Quan. ZPMC QC is identified as Liu Liang. The welding appeared to be in conformance with welding procedure specification, WPS-B-T-4132.
